MGA Archaeology - Chassis Identification

Robin Barker

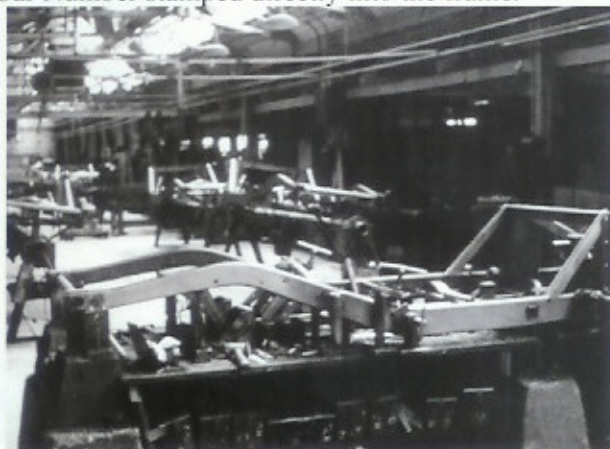
*Chassis construction at Abingdon
Photo: Courtesy Colin Grant*

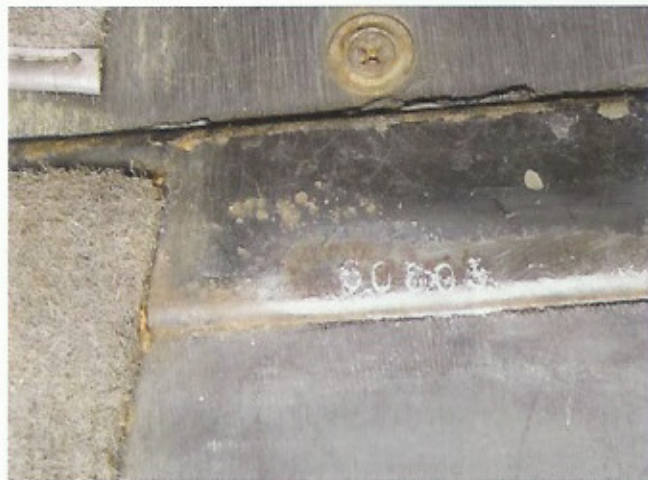
The photo below illustrates the serial number portion 60803 of the Car Number HMK/43/60803 stamped into the top face, along the rear edge of the right side, frame cross member tube. This square cross section tube is positioned near the rear of the transmission and lies directly under the knees when seated in the right hand seat. The 2 floorboard securing screws further define the location. This stamp is in the same location on all UK assembled, CBU, MGAs, regardless of whether they were built with left or right hand steering. The individual stamped numbers are each 1/4 inch (6mm) high.

*Serial number 60803 on right hand cross member
Photo: Robin Barker*

Unfortunately the ravages of water soaked floorboards and interior carpeting have often left this car serial number deeply rust pitted and difficult if not impossible to find. The percentage of MGAs where this number has survived and can still be seen is probably very low. Cars used in a dry climate or having lived cozy lives undercover are the best candidates.

The lads at MG did not wield a heavy hammer when they stamped in the individual numbers. The frame cross member tube has a relatively thin wall thickness and repeated blows to metal stamps positioned side by side distorted the top face leaving a rectangular shaped depression. The individual numbers were no doubt purposely stamped along the edge as the vertical wall of the tube offered additional stiffness. In spite of this however, in most cases the individual numbers were not stamped deeply and often were not fully formed.

The rectangular depression created by the car serial number stamps has proved to be both a curse and a blessing. Undoubtedly the rusting process was accelerated as nearby water tended to pool in this low area. However as an aid to targeting the best spot to search, the depression can usually be felt with the finger tips.

To uncover the car serial number, first remove any paint from the area with paint remover. Then use a stiff wire brush to vigorously clean the area of all dirt and oxidation. Under no circumstances should abrasive materials such as sandpaper, a grinding disc or heavy sandblasting be used in this area. As the stamp markings are often faint, any removal of un-oxidized steel will destroy whatever markings remain. Even when a fairly clear number is present it is not always immediately obvious and close examination with a magnifying glass may be required to recognize the numbers.

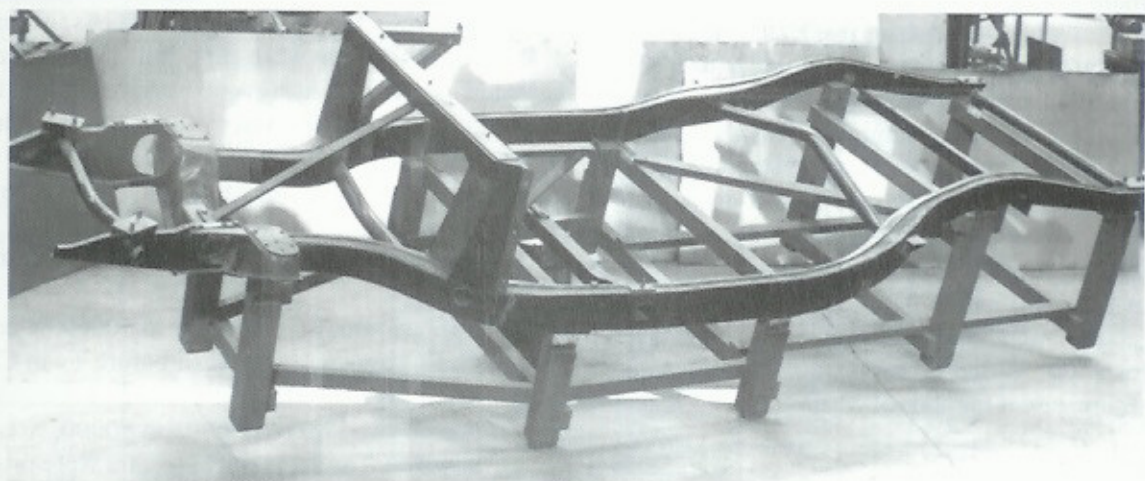
*Chassis Jig for CKD frame construction
Photo: Courtesy Piers Hubbard*

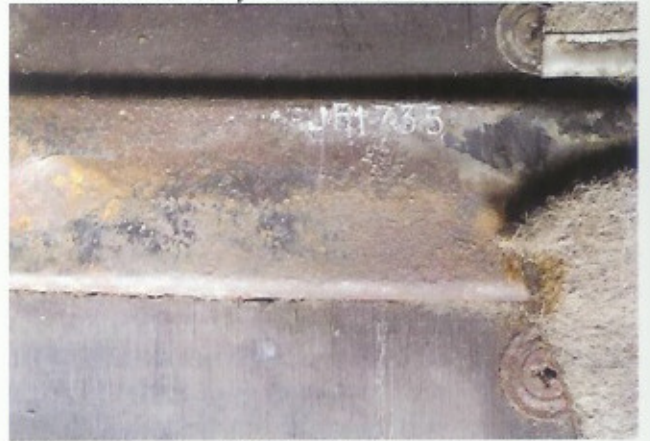
Frame number J51735 on left hand cross member

The frame serial number is stamped into the top face, along the front edge of the left side frame cross member tube. This tube lies directly under your knees when seated in the left hand seat. The two floorboard securing screws in the photo further define the location. The same rectangular depression exists to pinpoint the most likely location. The individual stamped numbers are each ¼ inch (6mm) high.

The photo below illustrates the actual frame serial number to be J51735. This frame is known to be original to HMK/43/60803. The predicted number 51203 is remarkably close to the actual 51735.

As revealed in "Call It MGA", "There was also a single number beneath which may well be the "signature" of a particular inspector". Reference to the photo above shows that this particular frame may have been checked in the weld shop by a MG inspector with the J approval stamp. Several other frame serial numbers are known to have either the prefix or suffix letters A, B, C, F and O, while many others have no letter or any additional number.
